OFFICE OF THE AUDITOR GENERAL

ENGINEERING AUDIT OF UGANDA NATIONAL ROADS AUTHORITY (UNRA), 2009

Final Report

March 2010

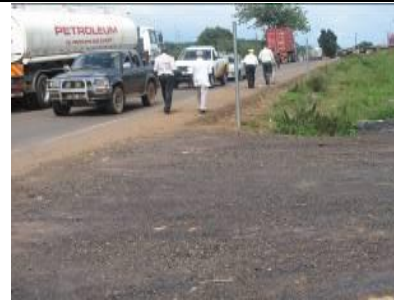
Missing sign and poor surface dressing at Magamaga access

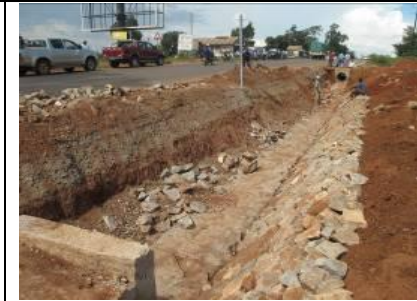
Repair of damaged lined drain at Iganga

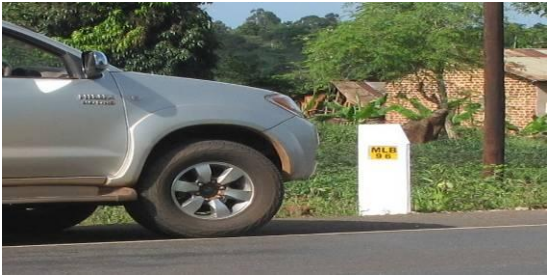
carriageway section is low and could favour unlawful drivers to drive over the median.	The low height of kerbs was partly due to late change (after the kerbs were in place) in the thickness of w/c from the original 35mm to the present 60mm. Raising the kerbs at a later stage would mean digging up the road which could cause damage to the pavement.	alternative solution to avoid damage to the median.
ii)	The lettering on Kilometre posts is small and may not serve their purpose to some road users especially drivers (see picture below).

Correct observation. This is the size of the letters that were indicated in the design. The audit observation is noted and it will inform future and ongoing projects where kilometre mark posts have not yet been produced	This was inappropriate design and should not have been accepted in the first place. This shortcoming should be rectified by UNRA.
iii)	The rubble strips were not of appropriate standard.	Correct observation. This issue was raised to the Contractor as a snag. The rumble strips have since been rectified to acceptable standard.	UNRA should follow up.

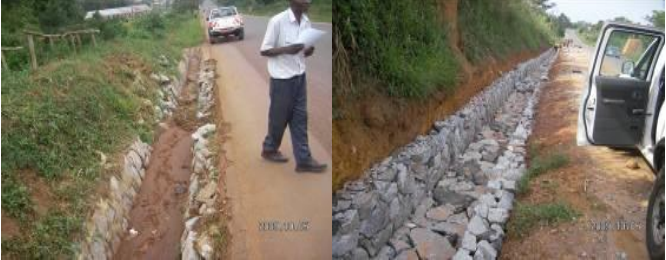
<p>vi)</p>	<p>Quality of stone pitching not good</p>

<p><i>Stone pitching works on drains. Not done to good standards</i></p>	<p>Its true some sections of stone pitching are not good. These will be put right during the defects liability period and before handing over the road</p>	<p>UNRA should follow up and ensure the defects are corrected.</p>

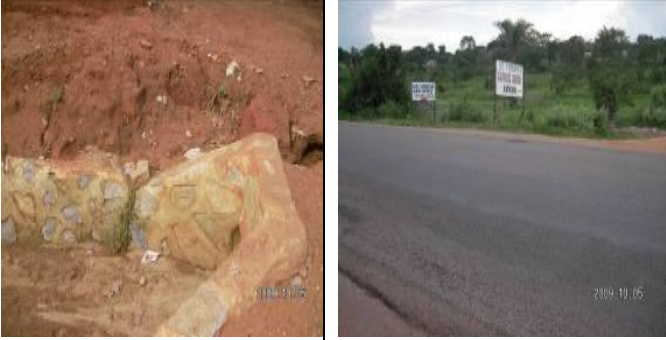
<p><i>Earth above channel will result in silting of channel. Need to remove before rains</i></p> <p><i>Re-sealed road surface. Quality looked good on some sections but not good on others</i></p>		
<p>The auditors conducted a detailed assessment of the roads on 31st October 2009 in the presence of the UNRA Project Manager and the Consultant's representatives (names in Annex 2). The Contractor was absent for non-justifiable reasons. The comfortable driving speed was about 90km/hr.</p> <p>The table below shows the audit tests carried out and corresponding results which are compared with the specification limits.</p>

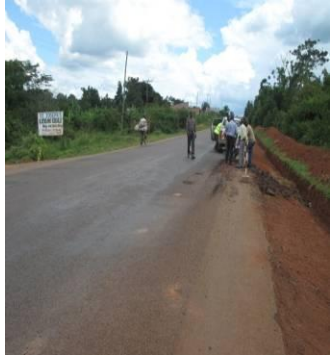
h.	Outstanding Technical Observations									
i)	There was observed rutting and heaving along some sections of the road (see picture below);

The heaving and rutting sections are to be fixed during the defects liability period			The contractor should rectify the defects. UNRA should follow up.			
			<i>Heaving section along the road</i>							
ii)	In trading centres, there were notable road edge failures			The fixing of the road edges will be planned for			UNRA to follow up.

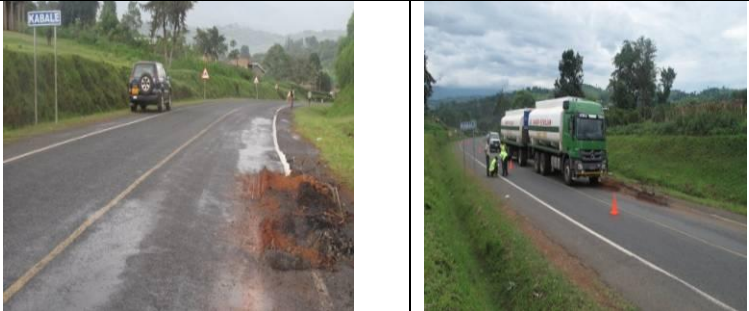
<p><i>Failures mostly along the loaded lane</i></p> <p><i>Heavy trucks along the loaded lane</i></p>		
ii)	Bleeding was noted at various spots e.g. at Ch. 11+700	Correct observation. Stone/quarry dust will be applied on the effected sections to address the bleeding problem whenever necessary.	Follow up by UNRA required.
iii)	There is a lined drain over a sub-surface drain at Ch. 51+900 that was poorly built. The mortar mix was doubtful because it was disintegrating upon light loading (see results table above).	Correct observation. Checked and actual problem investigated. The station engineer will attend to the defects.	The works were not done to perfection because of inadequate supervision.
iv)	There was poor surface dressing resulting into corrugations from Ch. 0 + 000 to Ch. 16+000. The rest of the road section was in good condition.	This surface was made up by application of a third bituminous seal at the Contractor's own cost. While the surface may not be very smooth, it more protected.	This is a result of poor workmanship and weak supervision.

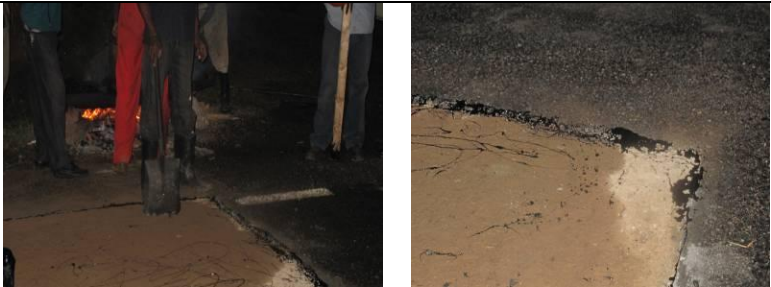
<p><i>Repair works being done late in the evening without supervisor, which failed later</i></p>		
	Generally, the above defects are a responsibility of the Contractor, the Consultant and the Client

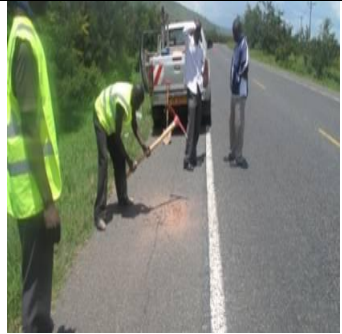
e.	Outstanding Technical Observations		
i)	<p>There were longitudinal and transverse cracks mostly pronounced along the RHS shoulder way from Katunguru – Kikorongo – Kasese (see pictures below). The cracks were being repaired as a temporary measure by the Station Maintenance gang by the time of this audit.</p> <div style="display: flex; justify-content: space-around;"> <div data-bbox="255 512 595 847">

<p data-bbox="255 852 595 970"><i>Longitudinal crack being investigated by the audit team</i></p> </div> <div data-bbox="624 512 954 847">

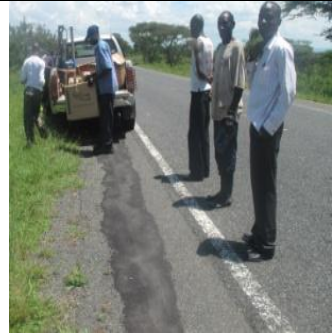
<p data-bbox="624 852 954 970"><i>One of the sealed cracks</i></p> </div> </div>	<p>True. The repairs are being carried out by the station as part of their routine maintenance duties.</p>	<p>UNRA should establish the causes of the failures/cracks so as to provide an appropriate solution.</p>
ii)	<p>Stripping of aggregates was noted at Chainage 77+000 RHS shoulders.</p>	<p>True, the wearing course on the shoulders was single bitumen surface treatment and this is not adequate especially where traffic commonly use the shoulders. UNRA has now decided that all future shoulder construction will be with double bitumen surface treatment.</p>	<p>The stripping should not be occurring if the single seal was applied properly. This could be a problem of workmanship.</p>

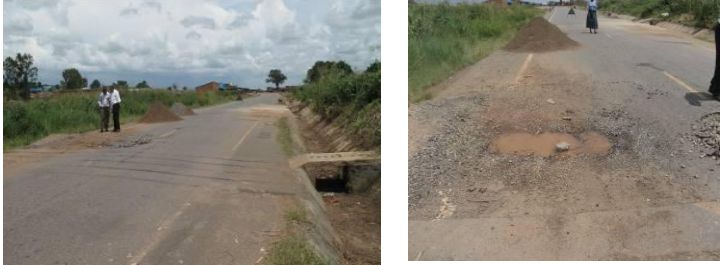
<p><i>Failed section on the approaches to Olwiyo trading centre</i></p>

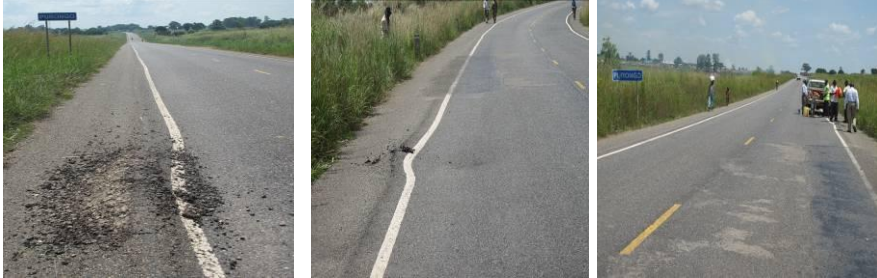
<p style="text-align: center;"><i>Heaving and potholes</i></p>		
<p>ii)</p>	<p>There were wrongly placed road signs e.g. showing a sharp left turn when instead it is a sharp right turn (Ch. 39+700 RHS), see picture below;</p>

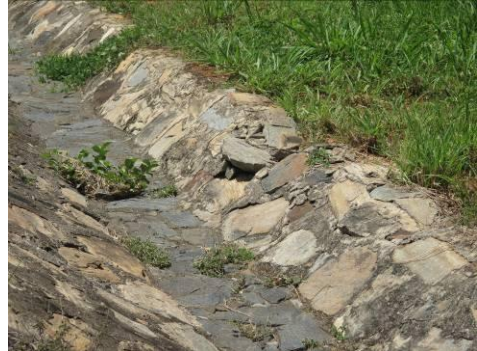
viii)	<p>Some sections of the lined drains had failed i.e. mortar disintegrating from the stones (see picture below).</p>

<p>Observation is correct. At the time of handing over of the road the drain was functioning well. The failures have been noticed recently and the responsible station engineer will attend to them</p>	<p>The defects could be attributed to poor workmanship and inadequate supervision. UNRA should follow up.</p>
ix)

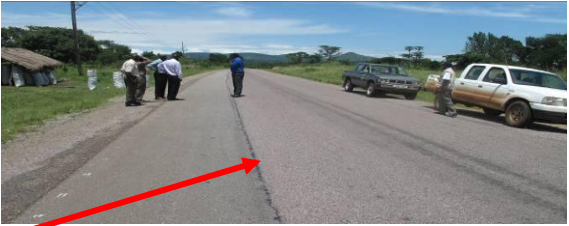
<p>noted between Ch 90+400 and 90+700 RHS;</p>

<p><i>Bleeding section</i></p>	<p>and replace the bleeding areas.</p>	
<p>iii)</p>	<p>In trading centres, there were notable road edge failures;</p>

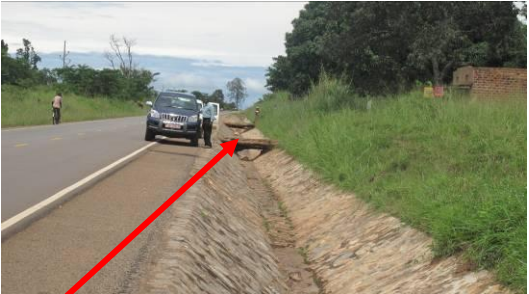
<p><i>Improvised community accesses</i></p>	<p>UNRA will provide well designed accesses where it becomes necessary and also continue maintaining the drains.</p>	<p>UNRA to follow up.</p>
<p>v)</p>	<p>The white road marking paint was peeling off before hand-over of the road. The width of both the white</p>	<p>The contractor will have to rectify all defective road marking and any other works before handing over</p>	<p>UNRA to follow up.</p>

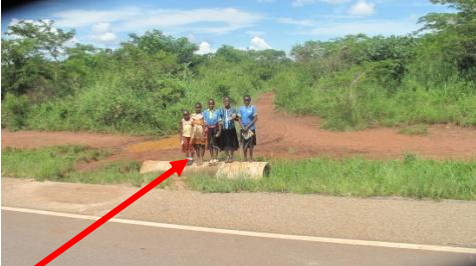
<p><i>Exposed culverts awaiting backfilling</i></p>	The contractor is to accomplish all outstanding works before handing over.	UNRA to follow up.
vii)	UNRA has made an effort of installing road reserve posts along this road.	True, for information.	Good practice
viii)	Generally, the above defects are a responsibility of the Contractor and the Consultant.		
ix)	There was an I-section at Ch 124+000 which is 11m long, 0.92m wide/0.85m internal width. This section could be used on other water crossings in the country but was just abandoned.	The I-section found on the site is the property of the contractor and they will be instructed to remove it from the road corridor.	UNRA to follow up.

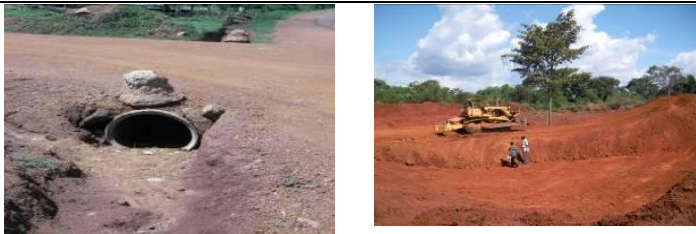
<p><i>Drainage channel way above invert level of culverts. Road works on going</i></p>		
	Road status during detailed assessment The auditors conducted a detailed assessment of the road on 10 th November 2009 in the presence of the UNRA Station Engineer and Assistant Engineer–Jinja; the Contractor's Site Engineer and Site Agent (names as in Annex). There was a general observation that the contractor had rectified the surface defects that

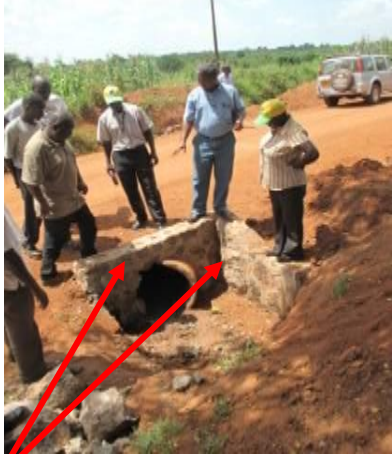
<p><i>Poor culvert headwall and wing walls</i></p>	<p>Observations to be addressed during the defects liability period. For all our future contracts we shall ensure that we have a bill item on road signs</p>	<p>UNRA to follow up.</p>
<p>iv)</p>	<p>The Bills of Quantities lacked an item of road signs to cover safety features;</p>		
<p>v)</p>	<p>Some of the mitre drains seen were silted.</p>		
<p>vi)</p>	<p>There were long stretches on hills without lined drainages or scour checks to check the speed of water.</p>		
<p>i.</p>	<p>Value for Money The average cost per km of UGX 32.749.265 is within costs for similar works in the country</p>		
<p>j.</p>	<p>Recommendations</p>		
<p>i)</p>	<p>Review Consultants Contract terms of reference clearly specifying the level of works to be supervised;</p>	<p>Recommendations by Audit Team are noted and they will be implemented</p>	<p>UNRA to follow up</p>
<p>ii)</p>	<p>The road length should be re-confirmed by chaining.</p>

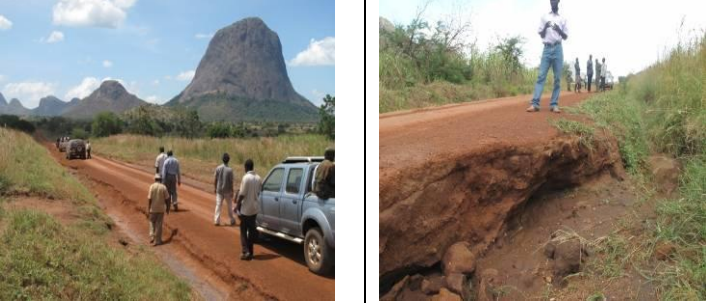
<i>Destroyed road sections due to lack of drainage culverts</i>		
iii)	There were low spots identified that require filling. This was however outside the scope of works under this contract.	The low lying areas that require raising will be worked on by UNRA Force Account Unit in May 2010 after expiry of the Defects Liability Period	UNRA to follow up.
iv)	There was rutting noted along un-gravelled sections. Heavily loaded World Food Programme trucks ply the route on a daily basis. This, coupled with the small thickness provided of 75mm could be the cause of the rutting (see picture below).

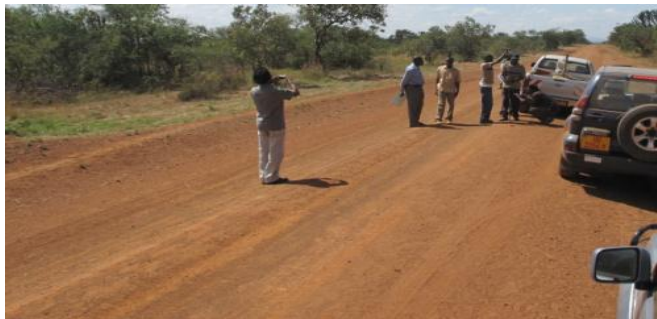
<i>Rutting along un-gravelled section</i>

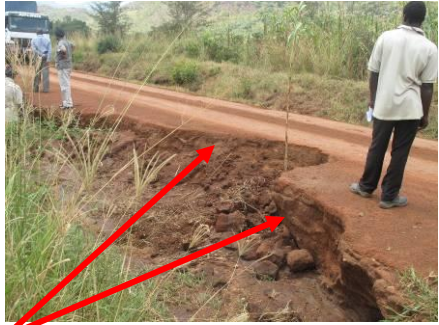
<p><i>Deep cut nearly one lane left</i></p>		
<p>i.</p>	<p>Value for Money The average cost per km of UGX 16.470.154 is within the cost for similar works.</p>		
<p>j.</p>	<p>Recommendations</p>	<p>Recommendations by Audit Team are noted and they will be implemented.</p>	<p>UNRA to follow up.</p>
<p>i)</p>	<p>The road section lengths should be re-confirmed by chaining.</p>		
<p>ii)</p>	<p>The Local Authorities should intervene by sensitising residents about the need for culvert outlets and catch water drains.</p>		
<p>iii)</p>	<p>UNRA should consider commissioning additional works of emergency in nature along this road section at particular spots. Consideration for gravelling the remaining sections should be recommended.</p>		
<p>iv)</p>	<p>The Station Engineer should ensure the contractor rectifies the snags identified before final acceptance of the works.</p>

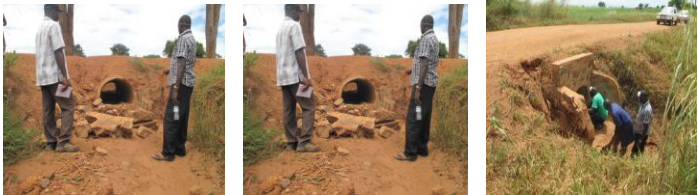
<p style="text-align: center;">Defective culvert works</p>		
ii)	<p>There was severe erosion along some headwall surroundings caused by inadequate compaction. There were sections where there was evidence of water ponding as a result of loss of camber leading to pothole formation (see picture on road condition above).</p>	<p>This observation is correct. The erosion along the headwalls is to be corrected by the Contractor during defects rectification process. Loss of camber is attributed to the high traffic levels on the road coupled by high axle loading. Plans are underway to grade the road in April 2010.</p>	<p>UNRA to follow up.</p>
iii)	<p>“Supply, delivery and installation of corrugated metallic pipe culverts, use for bedding and filling approved materials”, was done in 3 places each of 8m length but the total length measured and certified was 40m; the difference of 16m is not accounted for.</p>	<p>The installation was done in 3 places; Ch. 68 + 400 (1 line) Ch. 68 + 600 (2 lines) and at Ch. 68 + 650 (2 lines) all totalling to 40 lm. Hence all the 40 lm is accounted for. See photographs enclosed under separate cover.</p>

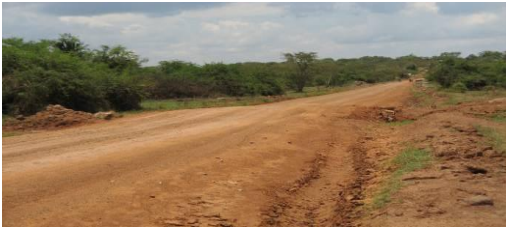
<p><i>Hump created as a result of laying culverts after gravelling</i></p>	<p>True, the humps have now been flattened and there is no safety risk at the locations.</p>	<p>Audit verification of the response on 10th March 2010 showed that the defects had not been corrected.</p>

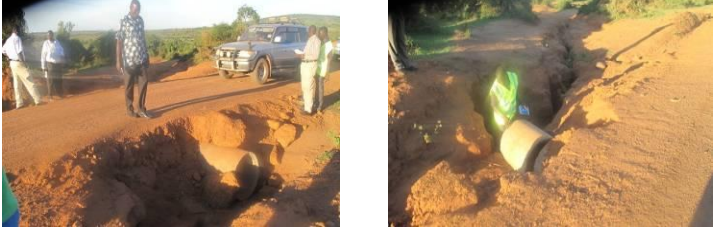
<p><i>Poorly installed culverts showing less pipe cover and disjointing</i></p>		
<p>iv)</p>	<p>The road traverses a relatively flat terrain and long low spots (see pictures below). The carriageway was getting washed away due to flooding / water ponding along these spots. The designer takes responsibility of this oversight.</p>	<p>Estimates for improvement of drainage on the entire road have been submitted by the Station Engineer. UNRA is considering a separate contract for drainage improvement on the entire road and also other roads due to the increased</p>	<p>UNRA to follow up.</p>

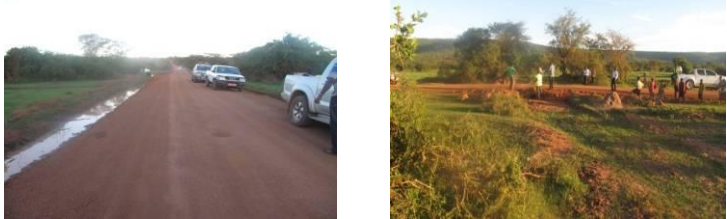
<p><i>Flat terrain prone to flooding and silting due to poor drainage intervention and poor camber</i></p>	scope of the works.	
v)	<p>Reconnaissance revealed that compaction was being done without adequate moisture leading to poor results as shown in the pictures below;</p>

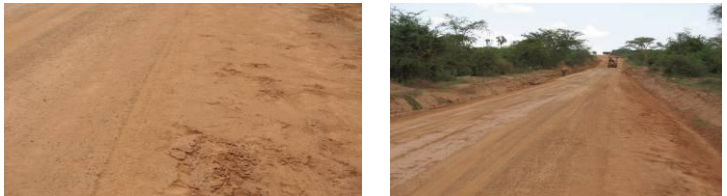
<p><i>Poorly compacted grave</i></p>	True, this was noted at the time of construction and the contractor was instructed appropriately. Some of the sections with poor results are to be rectified by the contractor.	Response is satisfactory. UNRA to follow up.

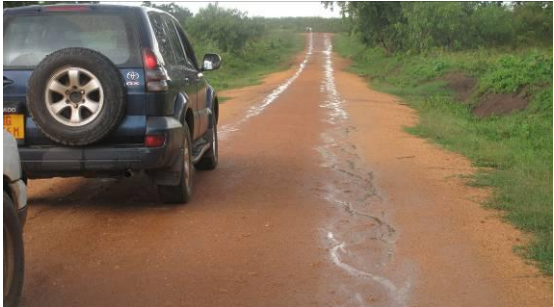
<p><i>Less gravel and no camber at Kabaale</i></p>	It is true that some sections were found to have less thickness of gravel. As mentioned under Quality of Works above, the contractor was notified and at the time of the audit survey these were still being rectified. The rectification was completed by the end of December 2009.	Defects were corrected.
iii)	<p>Some of the installed culverts had notable defects; Culvert bedding appeared weak, jointing of the pipes was not done for some culverts, the pipe cover was less than the recommended i.e. was between 170mm to 200mm instead of 450mm for a 600mmϕ culverts. Culvert headwalls and wing-walls were not properly designed (see pictures below). Culvert outlets levels were not as desired and there was notable silting and water ponding.</p>	It is true that some of the installed culverts had notable defects. As mentioned under Quality of Works above, the contractor was notified and rectification was done and completed by the end of December 2009.	Defects were corrected.

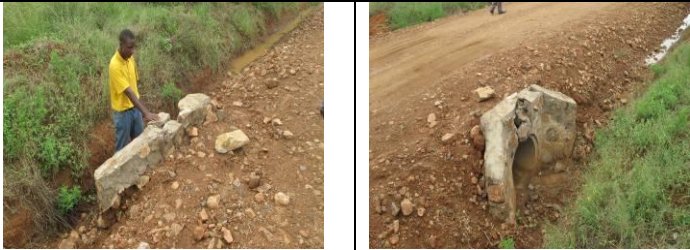
<p><i>Same spot where culvert headwalls had cracked on both sides</i></p>		
<p>iv)</p>	<p>Some of the mitre drains seen were non-functional.</p>	<p>It is true some mitre drains were non-functional at the time of audit survey. These have since been rectified.</p>	<p>Defects were corrected.</p>
<p>v)</p>	<p>Some sections of the road that have river crossings were poorly prepared i.e. no proper river training was done. The crossings flood during the rainy season and are washing away the fill material (see picture below).</p>

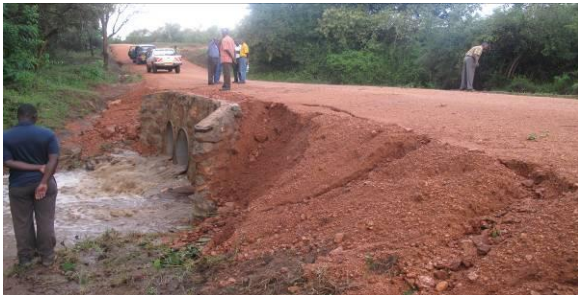
<p><i>The section during the rainy season floods</i></p>	<p>It is true that at the time of audit survey some sections of the road that have river crossings were in poor shape and the fill material was being washed away. This problem is being handled by force account. River crossings handled so far include Wambabya Bridge at km 34.5, Rutoha Bridge at km 53 and Hohwa I and Hohwa II drainage structures at km 55 and Km 57, respectively.</p>	<p>UNRA to follow up.</p>

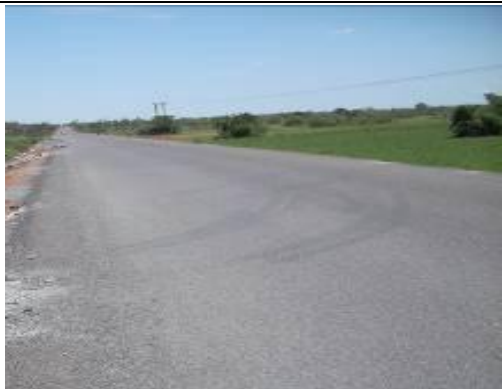
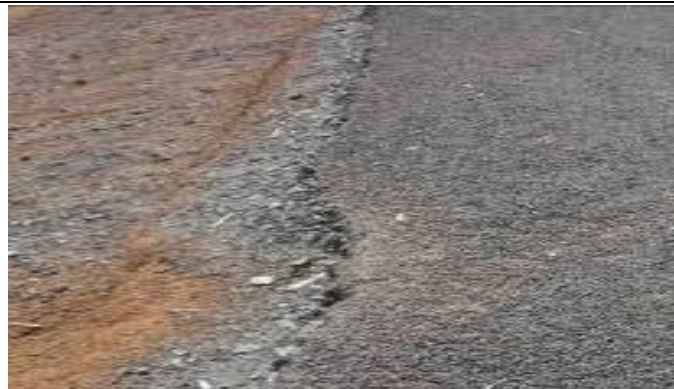
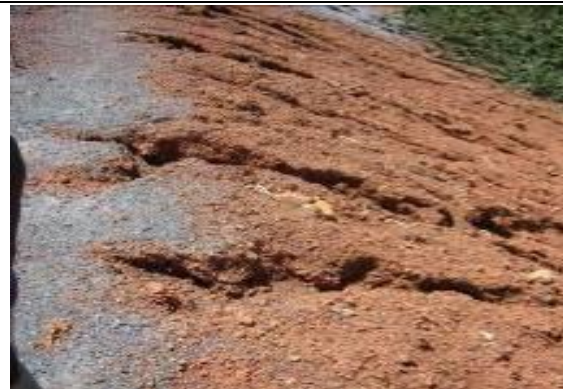
<i>Completed surfacing of carriageway. Quality of works is good</i>	<i>Road edge failures at populated areas. A need for road kerbs</i>	<i>Erosion of embankments seen at many locations. A need for planting of grass to prevent erosion</i>

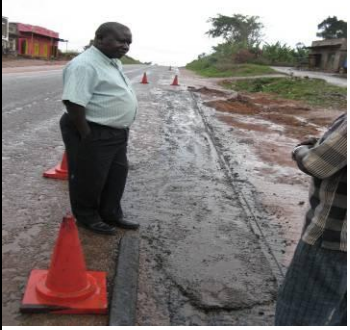
<p data-bbox="271 564 629 639"><i>Potholes and edge repairs using slurry seal</i></p>

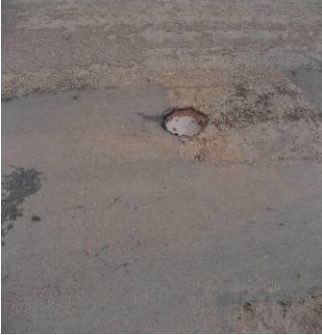
<p data-bbox="656 584 947 699"><i>Potholes appearing at edges of the repaired potholes</i></p>

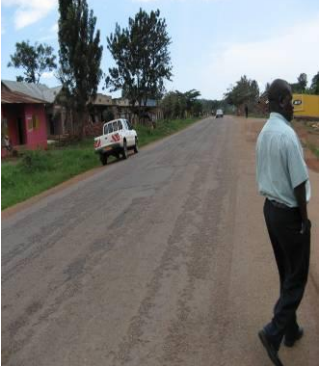
<p data-bbox="656 1118 965 1158"><i>Stripping of aggregates</i></p>		
<p data-bbox="271 1230 607 1262">Quantities Verification</p> <p data-bbox="271 1278 987 1350">Some of the payments certified in IPC No. 1 for up to October 2008 are as shown in the table below:</p>

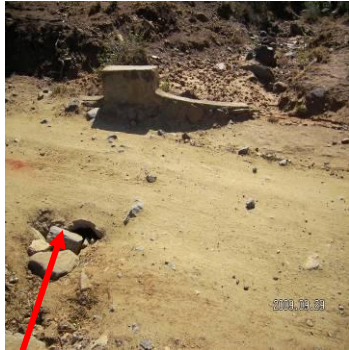
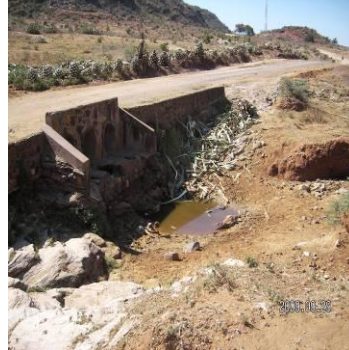
<p>Broken culvert in the middle of the road</p> <p>Multiple culvert structure outlet</p>		
e.	Supervision of Works The supervision of works was initially done by UNRA

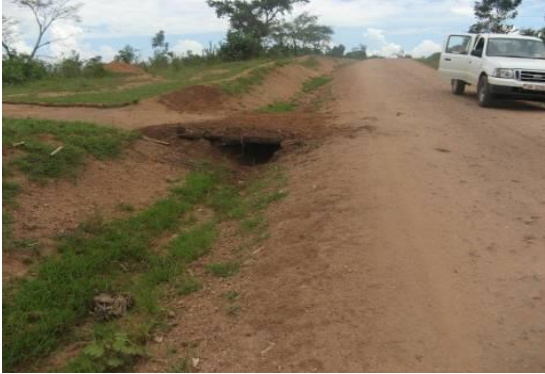
<p><i>Community improvised accesses</i></p> </div> <div style="text-align: center;">   <p><i>Under-scouring at Km 34</i></p> </div> <div style="text-align: center;">   <p><i>Cross drainage required at Km 56.1</i></p> </div> </div>

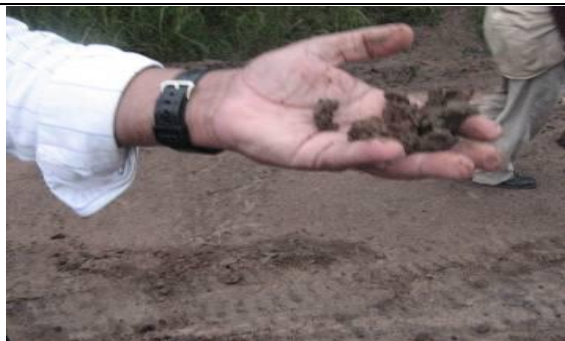
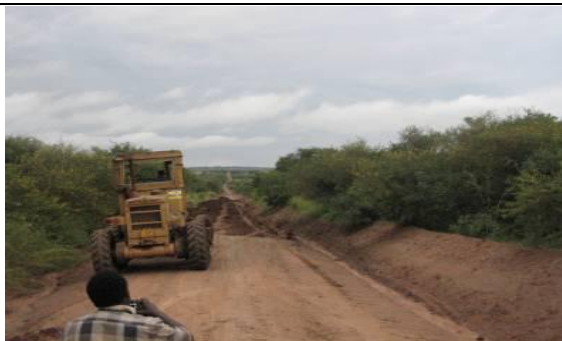
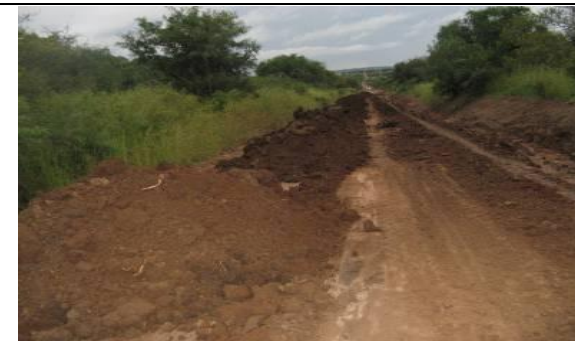
Poor quality clayey material dumped as fill material along fill sections

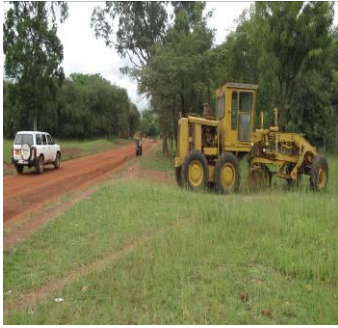
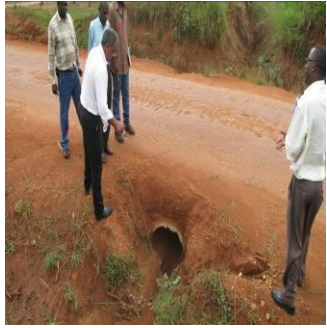
<p><i>Abandoned plant yet road works behind schedule</i></p>	<p><i>Uncompleted culverts. Headwalls.</i></p>

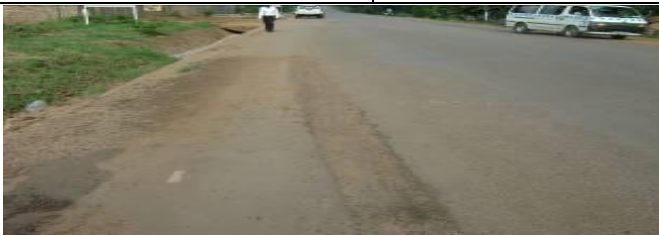
<i>A section of shoulder already sealed but stripping</i>

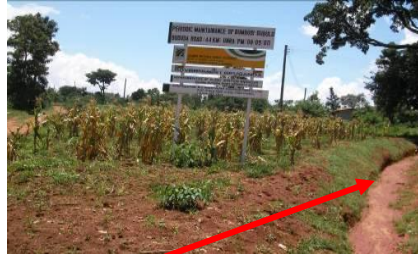
Side drain silted

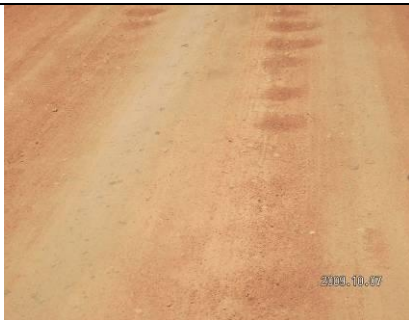
Recently gravelled section failed (poor Camber)

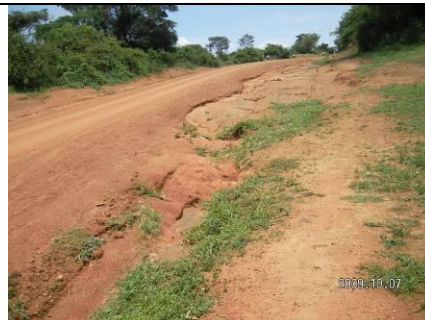
Poor drainage works affecting the road
