OFFICE OF THE AUDITOR GENERAL

ENGINEERING AUDIT OF UGANDA NATIONAL ROADS AUTHORITY (UNRA), 2009

Final Report

March 2010

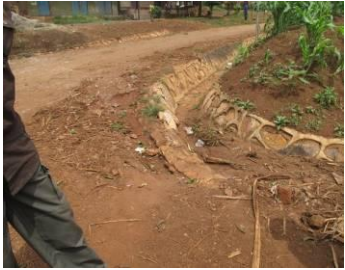
<p><i>Stripped access junction</i></p>	<p>These will be re-instated by the contractor as part of the snag list.</p>	<p>Contractor to rectify the defects. UNRA to follow up</p>
iv)	<p>At Bulumagi black spot, the team noted that a pothole had developed along Koonko junction (see picture below); there was a skew culvert (900mmϕ) installed but the outlet drain was very old and damaged; there was notable deformation on the road surface along the skew culvert indicating possible settlement due to weak culvert bedding;</p>	<p>These will be re-instated by the contractor as part of the snag list.</p>	<p>Contractor to rectify the defects. UNRA should follow up</p>

<p><i>Kooko access junction failure</i></p>

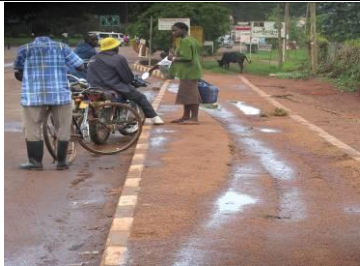
aggregates;			
vi)	At Lugazi – Kitega black spot, it was noted that shoulders, lined drains, footpaths and kerbstones were worked upon, however, some of the kerbstones were knocked down and vehicles were driving over the foot paths causing rutting (see picture right;

This is correct. The contractor will rectify these damages. Greater sensitization on proper road usage will be conducted by UNRA to minimize abuse of facilities.	Contractor should rectify the defects. UNRA to follow up
		<i>Ruts developed on footpath</i>		
vii)	At Namagunga Upper black spot, it was noted that there was minor rutting and some sections of the shoulders had been primed but not sealed. At Namagunga Lower, the surface dressing had been applied onto the asphalt wearing course at the contractor's expense in order to improve on the skid resistance;		Rutting has been noted on the climbing lane in Namagunga upper; and this is part of snag list. But there are no unsealed shoulders but there are sections of shoulders that have not been sealed at Bulyantete. These are included in the snag list.	Contractor should rectify the defects. UNRA to follow up

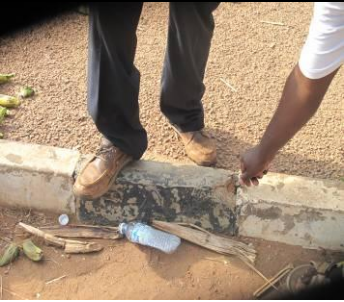
<p><i>Kerbstone identified as made of brick and painted</i></p>	<ul style="list-style-type: none"> • This is correct. The asphalt surface had developed hair cracks but still looking sound and even and within the specifications based on independent testing. The surface dressing has protected the AC from ingress of water. • This is not a correct observation, the shoulders had not failed. Rather the Contractor opted to apply two additional layers of asphalt concrete to correct irregular riding quality. Then applied asphalt concrete to shoulders to address the difference in levels between the pavement and originally surface dressed shoulders. This was done by the contractor on own cost. • The kerbstone in the photo is at Namawojjolo. It is included in the snag list and will be rectified as necessary. 	<p>Contractor should rectify the defects.</p>

kerbstones were made out of brick instead of concrete;			UNRA should follow up
xi)	<p>At Namawojolo black spot,</p> <ul style="list-style-type: none"> it was noted that two bus bays were constructed but by observation, one of them was bleeding. The culvert headwall on LHS had broken down. It was also noted that there was a fence designed to be fixed so as to stop meat vendors from running onto the road. This fence was never installed due to the vendors' outcries; 		<ul style="list-style-type: none"> This is correct and is part of the snag list. This is correct and is part of the snag list. This is correct observation 	<p>Contractor should rectify the defects.</p> <p>UNRA should follow up</p>
xii)	<ul style="list-style-type: none"> At Mbalala black spot, it was observed that access junction, kerbstones, footpaths and lined drains were constructed. It was noted that the main carriageway was failing and needed an intervention. It was also observed that rumble strips that had been fixed to reduce speed had flattened (see picture right);

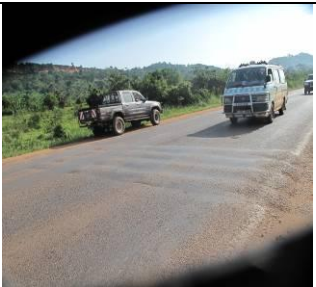
<p><i>Poorly constructed rumble strips</i></p>	<p>This is correct. Main carriageway was not included in the improvements under the contract</p> <p>The strips are to be rectified.</p>	<p>UNRA should take immediate measures to repair the failing section even though it was not part of the contract.</p> <p>Contractor to rectify the defects on the rumble</p>

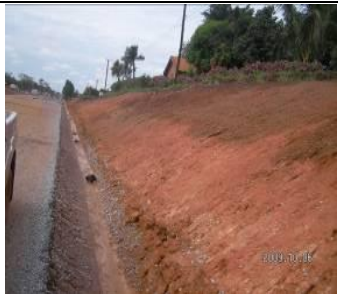
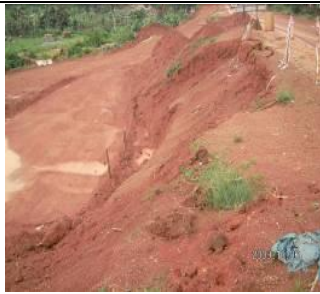
<i>Back slopes being washed away by rain</i>		<i>Road diversion not in good condition</i>						
e. Quantities Verification Interim Certificate No.10 was the last certified by audit time and was made use of in assessing some details of works certified.								
Pay Item	Work activity	Unit	Qty in the BoQ	Variation to date	Total done to date	Financial implication		
34.01(b)	Rock fill processing and compaction	M ³	3,000	4,279.50	7,279.50	336,481,101 (increment)		
34.02(b)	Selected sub-grade with indicated soaked CBR	M ³	18,000	50,216.98	68,216.98	974,661,365 (increment)		
i)	Item no 34.01b) Rock-fill processing and compaction,				This is a correct observation		The variation is noted to be

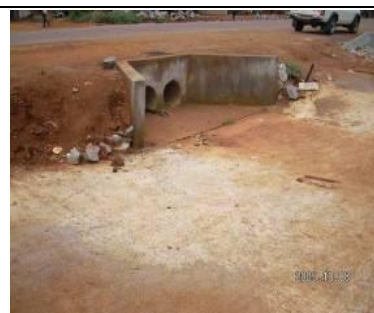
Culvert sections of insufficient size

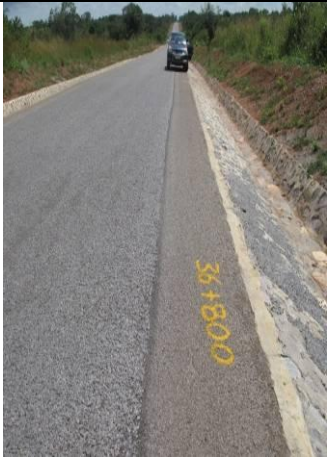
<p>iii)</p>	<p>It was noted that the contractor implementing works on this road section was the same for Kawempe – Luwero section. The quality of works on this section however was much better than the quality along the Kawempe – Luwero section. The Consultant was different (see picture right).</p>

<p><i>Good quality of wearing course seen on the road</i></p>	<p>Comparison of the quality of work on both sections is relative and could be true. Account has to be taken of the fact that the Kawempe - Luwero section is more trafficked and had no diversions implying that the road was constructed under live traffic.</p>	<p>Differing quality of works on the same road by the same contractor is an indication of lack of close quality control by the supervising consultant.</p>
<p>h.</p>	<p>Value for Money The average cost per km of 305 million UGX which is within the range of similar works in the country.</p>

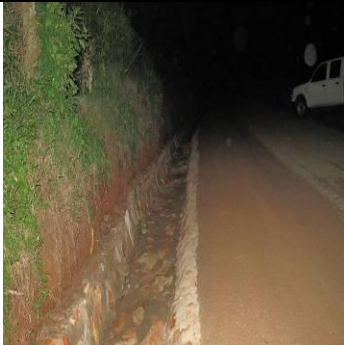
<i>Access road annexed to main contract works</i>

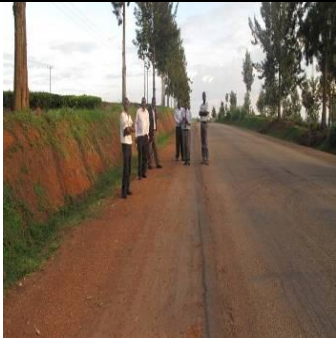
<i>Uncompleted work on shoulders</i>

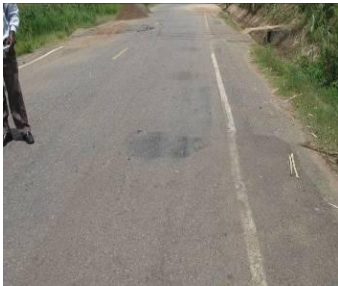
<p><i>Failed sections along the road</i></p>						
<p>The table below shows the audit tests carried out and corresponding results which are compared with the specification limits.</p>

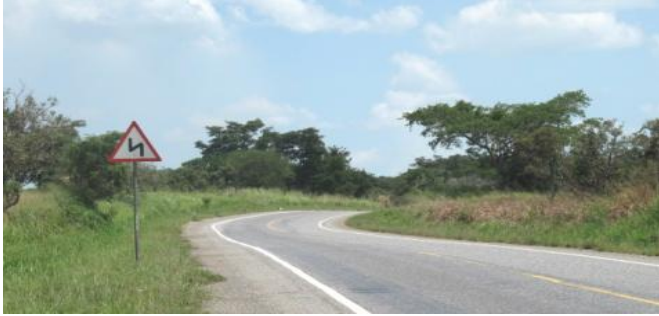
<p style="text-align: center;"><i>Heaving and potholes</i></p>		
<p>ii)</p>	<p>There were wrongly placed road signs e.g. showing a sharp left turn when instead it is a sharp right turn (Ch. 39+700 RHS), see picture below;</p>

<p style="text-align: center;"><i>Wrongly placed sign</i></p>	<p>The observation is correct. Since the road was handed over to the client, the responsible station engineer will be instructed to erect the correct sign at the location.</p>	<p>UNRA to follow up</p>
<p>iii)</p>	<p>There was limited community accesses provided along this road section and this had led to damaging of shoulders by residents trying to create their own access points.</p>	<p>The observation is correct.</p> <p>At the time of design and during most of the construction phase all the people were concentrated in IDP camps. The communities are now resettled and since the road has long been handed over to the client, the responsible station engineer will be given instructions to</p>	<p>UNRA should follow up</p>

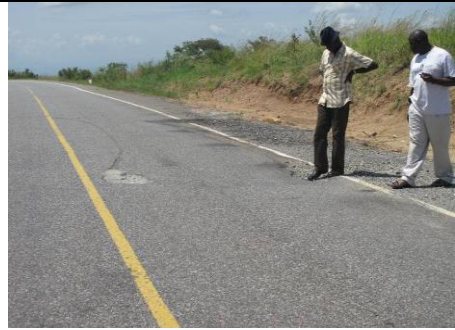
vii)	It was also noted that the road section experiences many accidents. There were tyre bust evidenced nearly every 3-4km. At Ch. 45+600, there was an accident where the tyre rims damaged the road pavement and the spot is a threat to more accidents unless repaired (see picture below).	The observation is correct. The responsible station engineer will be instructed to carry out the repairs as a matter of urgency.	UNRA to follow up. However a road safety audit is necessary on this road.

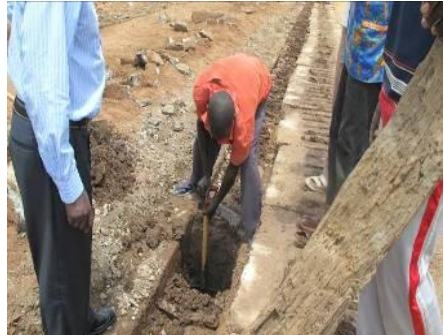
<p>The design of the drainage system to include heavy concrete covers at Purongo village resulted into heavy maintenance costs. The designs were noted to be inappropriate for this section of the road.</p>	<p>The observation is correct. Future designs will address this shortfall.</p>	<p>Designs should consider the future maintenance costs.</p>

<i>Heavy silting of drains : inappropriate design with heavy concrete slabs for covering causing a maintenance problem</i>		
	Generally, the above defects are a responsibility of the Contractor, the Consultant and the client.	The observation is correct. Since that the road was handed over to UNRA more than two years ago. We will therefore carry out the repairs to damaged sections as part of our maintenance regime.

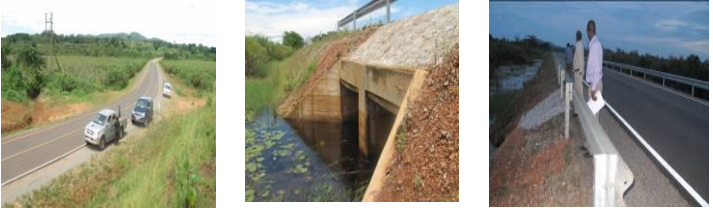
iii)	<p>Three Consultant firms were hired at different times to design the water crossing at Kafu river as seen in</p>	RAFU was concerned that the bridge of 360m over KAFU was an over design and this necessitated the	It is important that designs are reviewed for their

<p>the pictures below. It was not clear as to why there were changes in designs and whether all the Consultants were paid. However, the implanted option saved funds.</p>	<p>investigation that actually revealed that the bridge was an over design and a series of box culverts would suffice with a saving of funds. This option was eventually adopted with a saving of funds. All the consultants were paid for the services they provided.</p>	<p>appropriateness and cost implications by UNRA before the design consultants are paid.</p>

<p><i>Series of Box culverts that substituted the bridge</i></p>			
<p>d.</p>	<p>Quality of Works The auditors carried out a reconnaissance visit of the road on 5th October 2009, and a detailed assessment on 27th October 2009 in the presence of the UNRA Station Engineer and Road Inspector, Hoima, the Consultant's representative and the contractor's representatives (names as in Annex 2). There was a general observation that there was minimal works performed between the time of reconnaissance visit by the auditors and the time of detailed assessment. On the whole, the road was fully open to traffic and the condition was good.</p>	<p>The road is under defects liability period and only activities identified in the snag list are being addressed.</p>	<p>UNRA to follow up.</p>

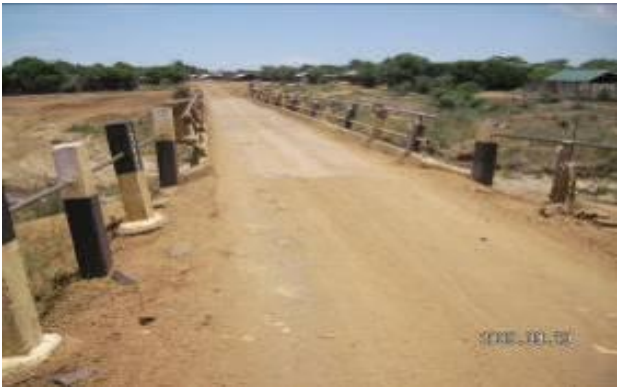
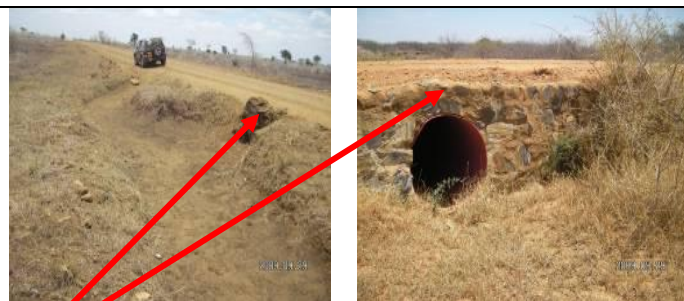
i)	The drawings included in the contract document were for paved roads instead of unpaved. Particular specifications include those of bitumen surfaced roads.		Proper drawings and specifications should be included in contracts to guide the contractors.
ii)	The contract signature was on 6 th February 2009 and yet the contractor's stamp indicates it was signed on 30 th January 2009.		It is important that the contract dates agree.
iii)	<p>No culvert or bridge works were planned for under the contract. Some of the existing ones required headwalls (see pictures below).</p>

<p>It is true under the contract no bridge works were planned to be carried out. However, it is not true that under the contract there are no culvert works. Items 3.8.2 and 3.8.3 are for supply and installation of 600mm and 900mm diameter culverts.</p>	Headwalls for the existing bridges and culverts should have been provided for.

Culverts Lacking headwalls

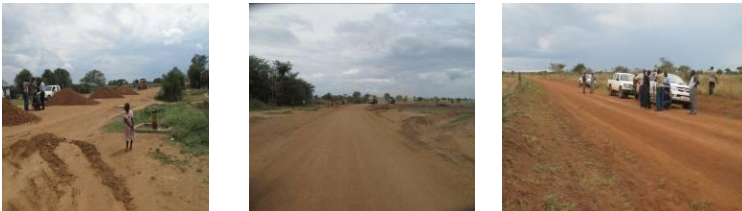
<i>Road condition at audit time, DCP tests were carried out on subgrade</i>

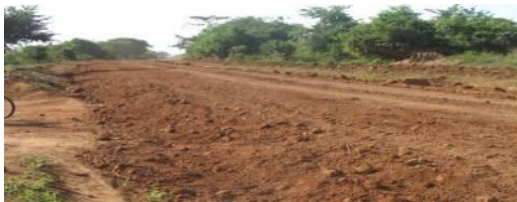
i)	The contract was to expire 1 day after the audit i.e. 11 th November 2009. No time extension had been granted;	Request for extension of time by sixty (60) days was submitted to Contracts Committee waiting for the approval	Extension yet to be granted.
ii)	The contractor had spread gravel over a long stretch of the road before compaction; this is not a good practice as it can affect traffic flow on the road (see picture below);

<i>Un-compacted gravel over long stretches</i>	The contract is substantially completed.	Materials should be spread in a manner that has minimum obstructions of traffic especially where diversions are not provided
iii)	Culverts were of good quality, however, the installed culvert joints were not sealed; the culvert line at Ch. 8+700 should have been skewed instead of cross. Culvert headwalls and wing-walls were not appropriately designed (see picture below); culvert pipe cover was mostly less than the expected requirements;

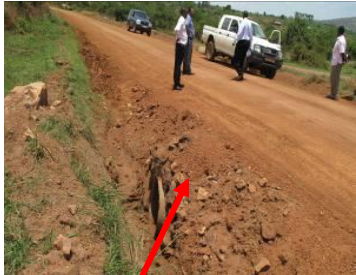
d.	<p>Quality of Works</p> <p>The auditors carried out a reconnaissance visit of the road on 30th September, 2009. Defects were noticeable on the carriageway that included potholes and culvert headwalls were cracked.</p>	<p>True, the contractor has agreed and has mobilized to rectify all the defects for which the risks are attributable to his performance. An inspection is to be conducted by all the parties once the contractor has completed the rectification of the defects.</p>	<p>UNRA to follow up.</p>
	<p>Status of road during Reconnaissance</p>

<div style="background-color: yellow; height: 280px;"></div>																												
<p><i>Missing headwalls and poor quality of finishes</i></p>	<p><i>Team observed compacting of gravel mixed with polythene and without adequate water</i></p>																													
<p>A detailed assessment of the road was carried out on 22nd October 2009 in the presence of the UNRA Station Engineer –Mbarara, the Consultant representative and the Contractor (names as in Annex 2). There was a general observation that the contractor had rectified surface defects identified during the reconnaissance visit and the safe riding comfort speed was about 65km/h. The table below shows the audit tests carried out and corresponding results which are compared with the specification limits.</p>

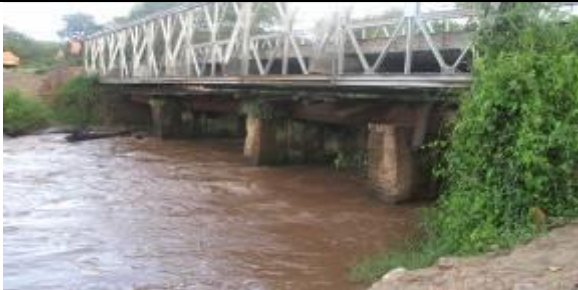
<p>vi)</p>	<p>There was Bailey bridge installed onto an existing bridge. No study report was availed to the team to confirm the necessity of the bailey bridge (see picture below).</p>	<p>It is true a Bailey bridge was installed onto an existing bridge over River Wambabya at Km34.5. This was done after a study was conducted by the UNRA Bridge Team. A study report was compiled</p>	<p>Study report seen.</p>

<p><i>Bailey bridge installed on existing bridge</i></p>	<p>by the team and is available.</p>	
<p>h.</p>	<p>Value for Money</p> <p>The average cost per km is UGX 83,186,113 which is considered high based on the going rates for similar works in the country.</p>	<p>The average cost per km of UGX 83,186,113 is higher than the average unit cost for ordinary regravelling works due to the factors below:</p> <ul style="list-style-type: none"> • These were emergency works that were absolutely necessary to enable facilitation of movements of wide and heavy trucks to the oil exploration areas around L. Albert in Hoima District in preparation for Early Production Scheme (EPS) that was scheduled for third quarter of 2009. The gravity of the urgency was expressed in the correspondences to UNRA from the Permanent Secretary Ministry of Works and Transport, Minister of State for Works and Transport (W) and in other correspondences in the same connection between the three concerned Ministries of Energy, Works and Transport, Finance, Planning and Economic Development and as well as one of the oil exploration companies (M/S Tullowoil). These correspondences are

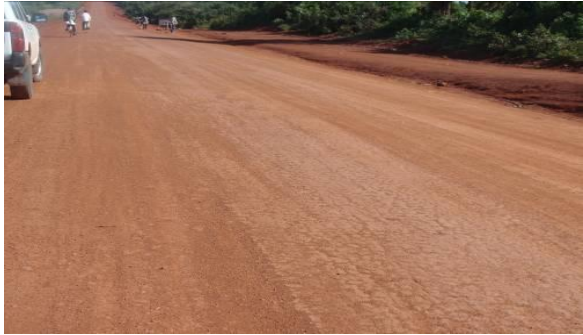
<p><i>Stabilised sub base ready to receive crushed stone base. The test results give very high CBR values</i></p>

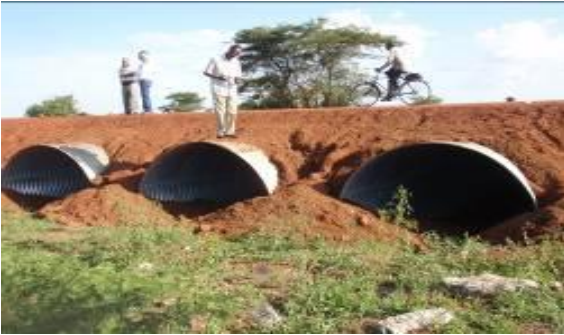
<p><i>The CMP culverts installed with gravel cover considered not sufficient.</i></p>

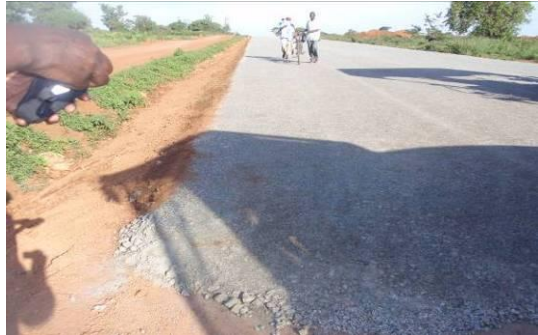
<p><i>Completed crushed stone base course. Quality of works looks good.</i></p>

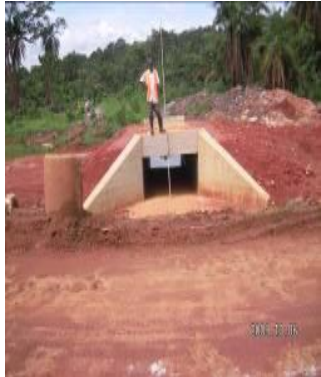
<p><i>Completed box culvert with wingwalls. Quality of works is good</i></p>						
<p>e.</p>	<p>Quantities Verification</p> <p>The actual quantities certified vide interim certificate No.7 compared to the quantities in the BoQ for some of the work items whose quantities have varied significantly and which will eventually increase the project costs are shown in the table below:</p>						
	<p>Pay Item</p>	<p>Work activity</p>	<p>Unit</p>	<p>Qty in the BoQ</p>	<p>Qty certified in IPC No 7 Sept. 09</p>

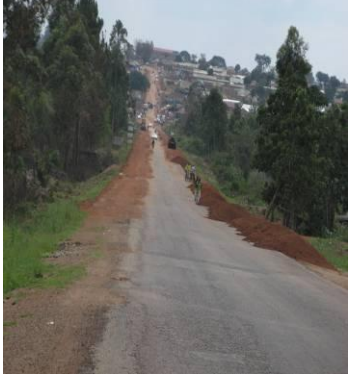
<p data-bbox="271 1126 622 1201"><i>On going edge repairs and shoulder construction</i></p>

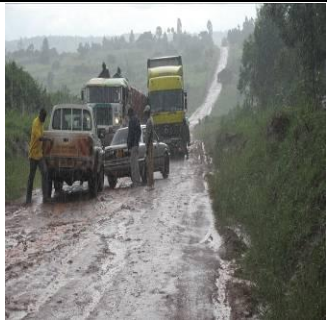
Manibe-Koboko

<p><i>Culvert at apex, excavated material likely to cause silting of the culvert</i></p>	<p><i>Poor state of the Road surface.</i></p>						
<p>e.</p>	<p>Quantities Verification The most recent certificate was issued on 11th June, 2009. The approved quantities for some work items compared to the quantities certified vide BoQ.</p>						
<p>Pay Item</p>	<p>Work activity (Manibe – Koboko)</p>	<p>Unit</p>	<p>Certified Qty</p>	<p>Estimated by Auditors</p>	<p>Remarks</p>		
<p>4.2</p>	<p>Shape the road surface by heavy grading to camber to and cross fall including side drains, all inlets outlets of the drainage using motor grader and compact to at least 95% MOD AASHTO</p>	<p>M²</p>	<p>70,000</p>	<p>18,900</p>	<p>The certified Qty was found to be more than actual on site by audit time</p>		
<p>f.</p>	<p>Supervision of Works Supervision of works is being done by Tamp Blessed-</p>		<p>This is true. Consultant will be informed to improve.</p>			<p>UNRA to follow up..</p>

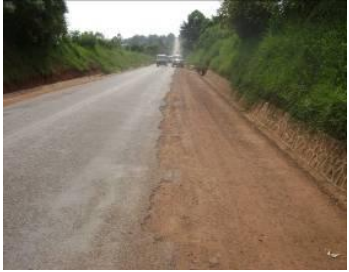
<p><i>Eroded road edge. The repairs should be done properly before sealing of shoulders</i></p> <p><i>Lined drains being constructed. A need for slabs for use by residents to access their homes</i></p>

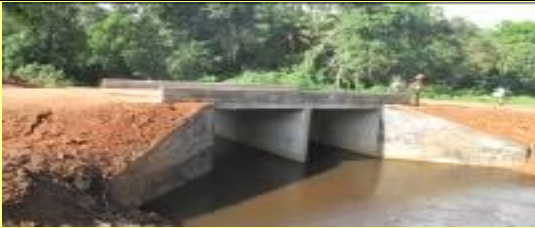
<i>Auditors inspecting the road</i>	<i>A box culvert in good condition. Requires protection of the slopes.</i>	<i>A well-finished section of the road</i>

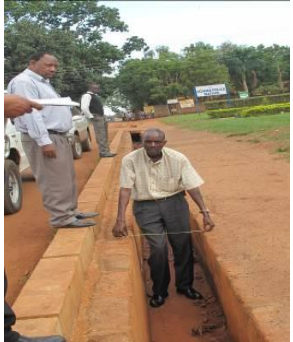
i)	Dangerous drainage system in Masindi town- too deep for pedestrians;	<p>had been executed and were in defects liability period. Therefore all decisions with regard to specifications, designs, quantities and approvals had been made in/by MoWT.</p> <ul style="list-style-type: none"> • However UNRA will look at the areas that require action/improvement like drainage systems and road safety measures; UNRA has already in place a programme for installation of traffic calming facilities on Masindi Township section <p>No MoWT responses</p>		
ii)	Though the specs requires use of 20mm size aggregates for 1 st seal and 10mm for 2 nd seal, this was not the case and the 20mm aggregates were seen on top;			
iii)	Carriage way is 6m on average in rural areas while it was 7m in Masindi town with 1.5 shoulders on each side.			
iv)	The road was holding well and no signs of bleeding/failures was seen

<p><i>Too deep and dangerous</i></p>

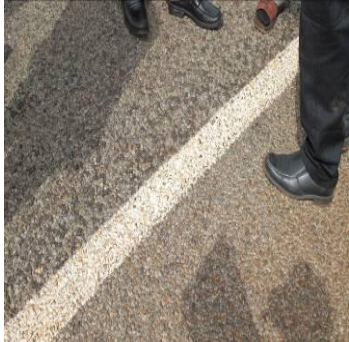
<p><i>Though large 20mm size</i></p>

<i>open drainage done to what specs and drawings?</i>	<i>aggregates were used for second seal specifications are for 10mm.</i>					
d.	Quantities Verification The most recent certificate was issued on 11 th August 2009. The actual works done for some work items compared to the quantities certified vide interim certificate No 12.			See comments under Documentation Review and Quality of Works above. No MoWT responses			
	Pay Item	Work activity	Unit	Qty in the BoQ	Qty certified in PC No12 of 11/08/09	Estimated Qty	Remarks

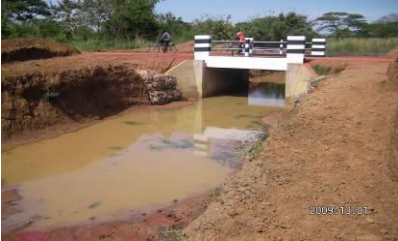
Repaired bridge over river	Lack of good drainage system	Lack of drainage

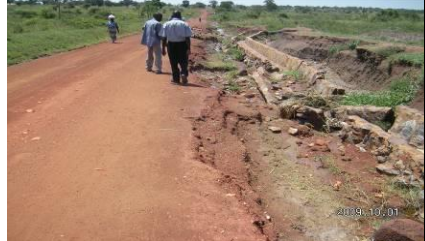
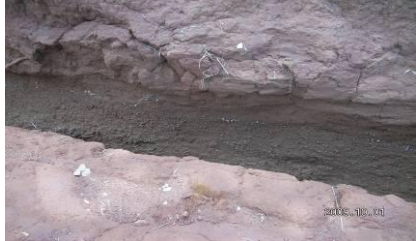
Existing drainage condition:	Side and mitre drains: insufficient	Culverts: insufficient
Field Observation	<ul style="list-style-type: none"> No design plans, drainage is a challenge Road in poor condition, erosion created gullies in the road, there is need for intervention. Culverts insufficient

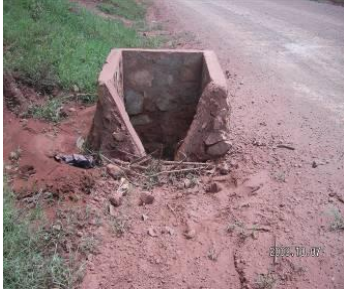
<p><i>Water-trap not built to standard</i></p>

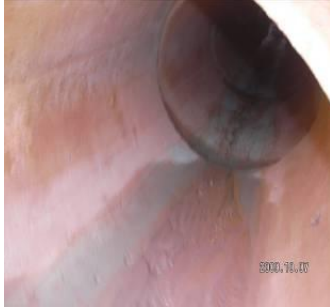
<p><i>Cracked culverts</i></p>

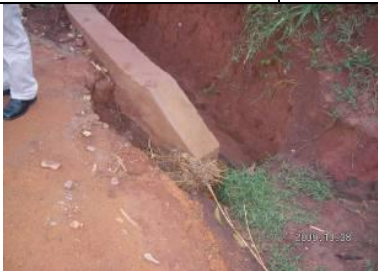
<p><i>Poor quality workmanship</i></p> </div> <div style="text-align: center;">

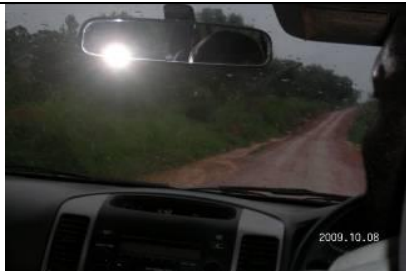
Existing drainage condition:	Side and mitre drains	Culverts:
Field observations:	<ul style="list-style-type: none"> • Water logged on both sides of the road in mist swampy sections weakening the road. • Most crossing culvert not skewed to allow easy flow of water • Too much water in Urban areas but no stone pitching provided for in the drains • Delay caused by transition from works to UNRA • Extra culverts required 	
<div style="display: flex; justify-content: space-around;"> <div style="text-align: center;">

<p><i>Drainage needs improvement</i></p> </div> </div>

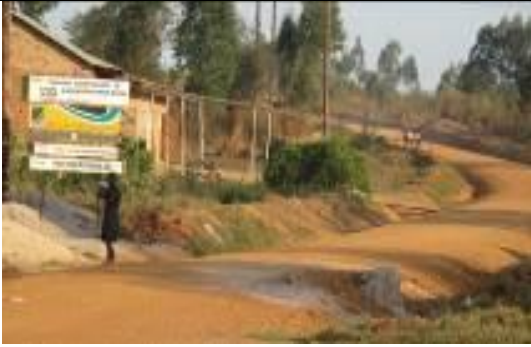
Fairly gravelled section

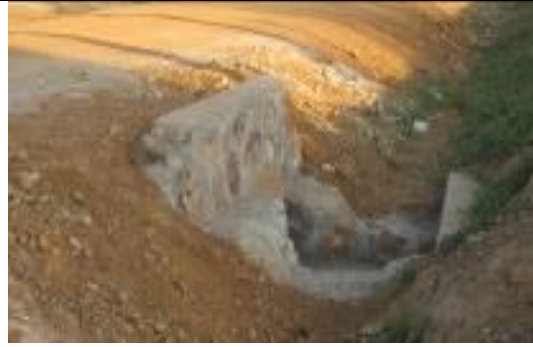
Questionable if headwalls was constructed according to design and specifications
